**NATURAL ICING FLIGHT TESTS AND ADDITIONAL SIMULATED  
ICING TESTS OF A UH-1H HELICOPTER INCORPORATING AN  
ELECTROTHERMAL ICE PROTECTION SYSTEM**

R. H. Cotton  
Lockheed-California Company  
P.O. Box 551  
Burbank, Calif. 91520

July 1978

Final Report for Period 17 February 1977 - 15 April 1977

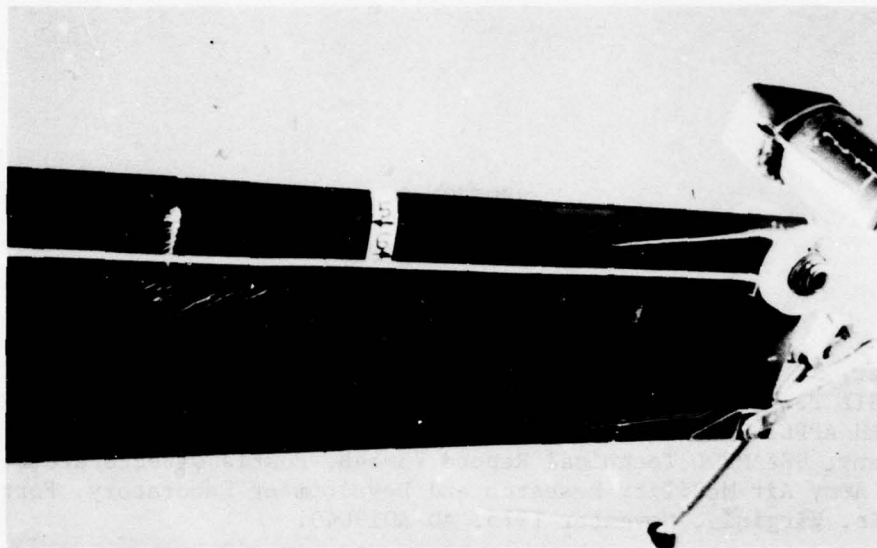
Figure 78. Lower Inboard Blade Surface Runback Condition  
Following 30-Minute Spray Rig Run - White Blade  
( $-18^{\circ}\text{C}$ ,  $0.35 \text{ g/m}^3$ , 6 Deice Cycles)

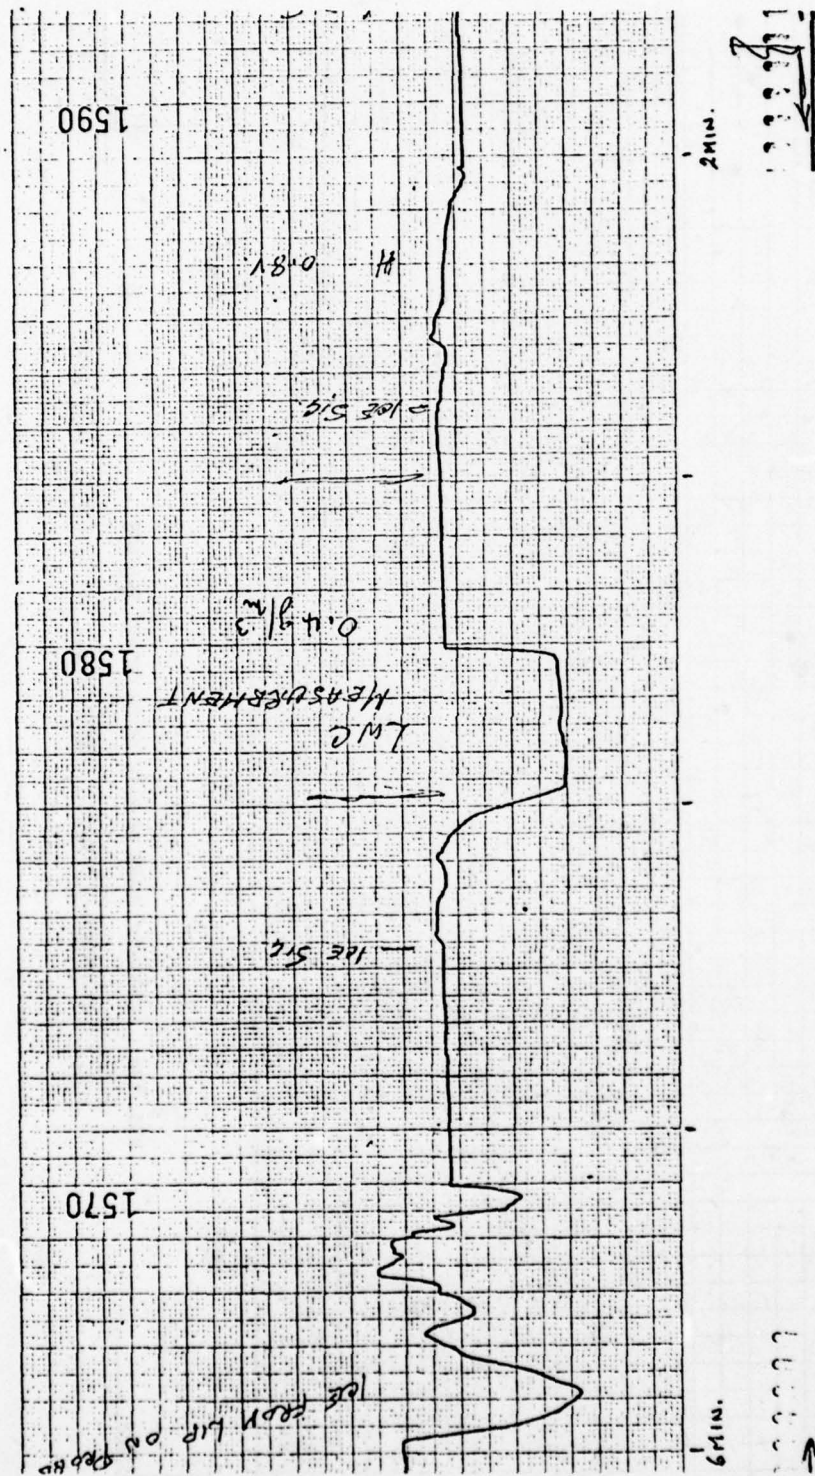
FIG. 11 RECORDER TRACE OF RATE METER OUTPUT VOLTAGE

It should also be noted that whenever a LWC measurement is made with the rotating cylinder, a decrease in the icing rate indication may be observed. This is because the rotating cylinder is placed directly ahead of the detector when the measurement is made. Such decreases during rotating cylinder measurements may be observed in Figs. 5, 10(a), 11, 14, etc.

150	-15	0.40	70	H	0.82	80	11	After 5 min. ice failed to shed from probe resulting in erratic readings.
150	-15	0.40	70	H	0.82	80	26	
30	-15	0.29	71	L <sup>+</sup> to L	0.25	270	12	Aspirator lip remained free of ice.
30	-15	0.45	71	M to M	0.4	155	13	Dip in voltage after end of "hold". Voltage becomes slightly erratic towards end of icing period.
30	-15	0.84	71	H <sup>-</sup>	0.8	80	14	Voltage somewhat erratic.

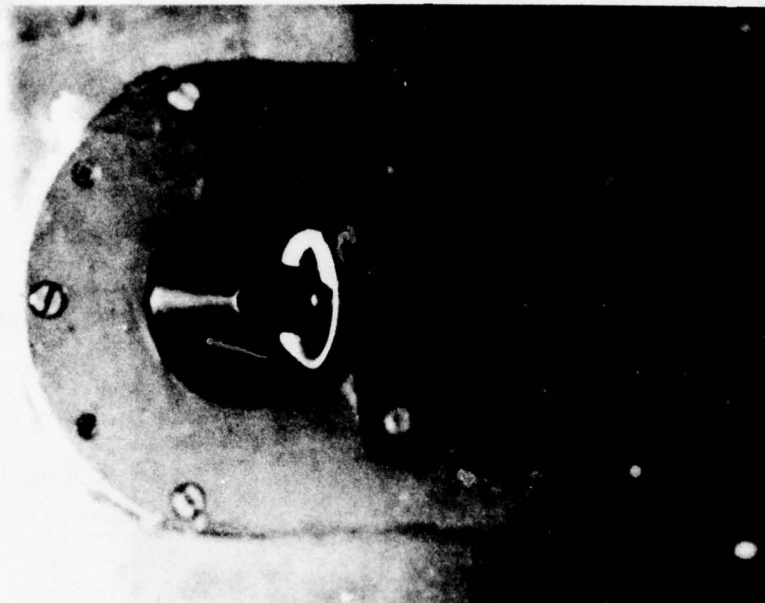
LTR-LT-76  
Fig. 25

It would appear that the expedient of notching the aspirator did not completely overcome the shortcoming of ice growth at the base of the probe such as experienced with the un-notched aspirator (Ref. 2). This problem, although particularly prevalent at a speed of 150 knots, also occurred at 90 knots with low air temperature ( $-15^{\circ}\text{C}$ ). Examples of these occurrences are seen in Figs. 7, 10(b), 11 and 20, and are categorized by an erratic output voltage followed, in most cases, by the output dropping to zero.

FIG. 25      SHOWING ICE ON ASPIRATOR LIP AND AT  
                 CORNERS OF NOTCH IN ASPIRATOR

AFTER 7 MINUTES AT 150 KNOTS,  $-15^{\circ}\text{C}$ ,  $0.22 \text{ g/m}^3$   
BLEED AIR PRESSURE 40 PSIG, TEMPERATURE  $69^{\circ}\text{C}$

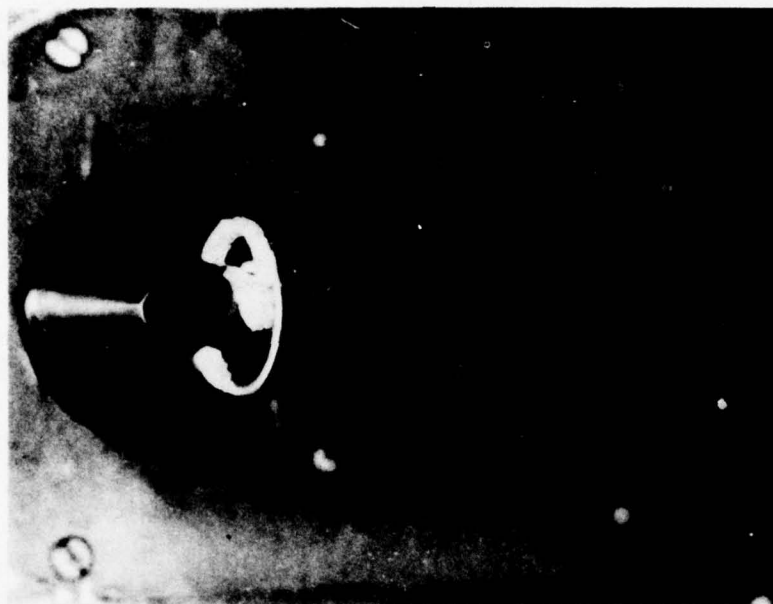
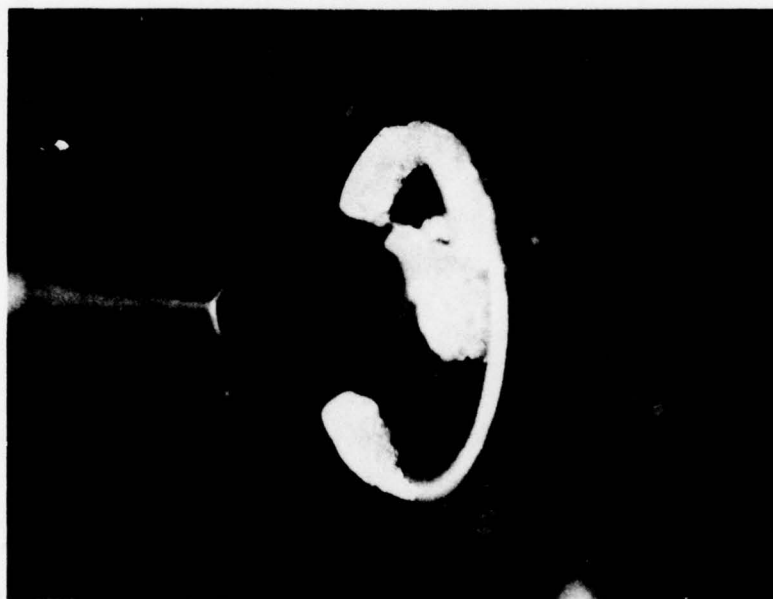
LTR-LT-76  
Fig. 26

FIG. 26      SHOWING ICE ON ASPIRATOR LIP AND  
                 AT BASE OF SENSING PROBE

AFTER 5 MINUTES AT 150 KNOTS,  $-15^{\circ}\text{C}$ ,  $0.4 \text{ g/m}^3$   
BLEED AIR PRESSURE 40 PSIG, TEMPERATURE  $70^{\circ}\text{C}$

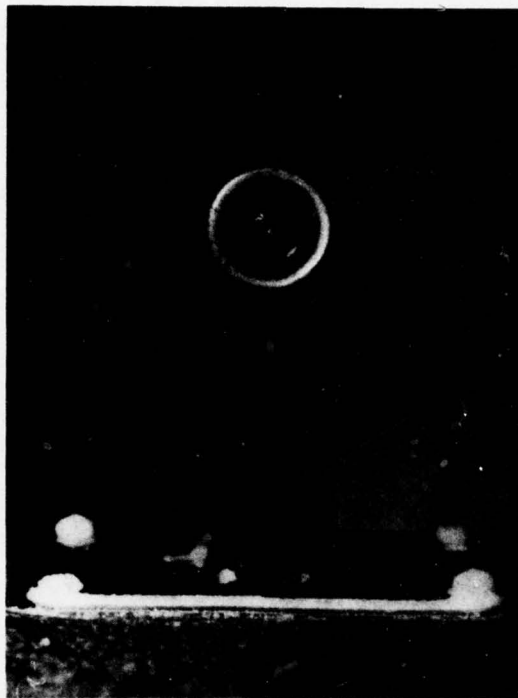
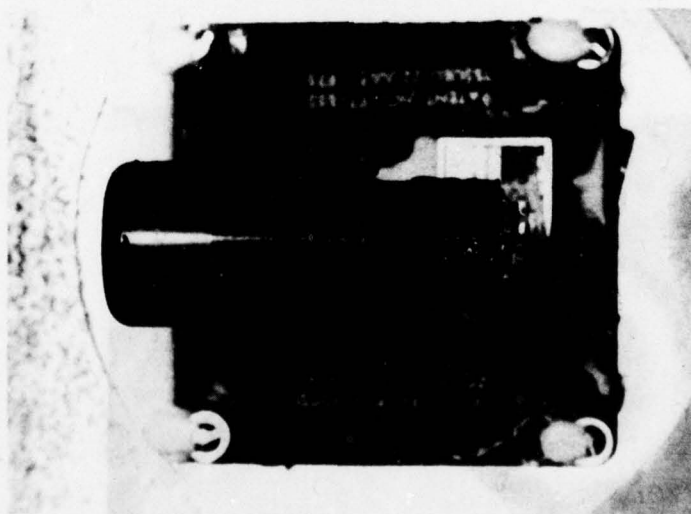
LTR-LT-77  
Fig. 6a

The static temperature was dropped to  $-18^{\circ}\text{C}$  with the same airspeed and liquid water content. Figs. 6a and 6b show the result after 5 minutes. Ice has now formed on both the outside and inside of the tail pipe. However, in spite of the fairly considerable blockage of the tail pipe, no abnormal effect on the LWC indications resulted.

FIG. 6a ANTI-ICING PERFORMANCE

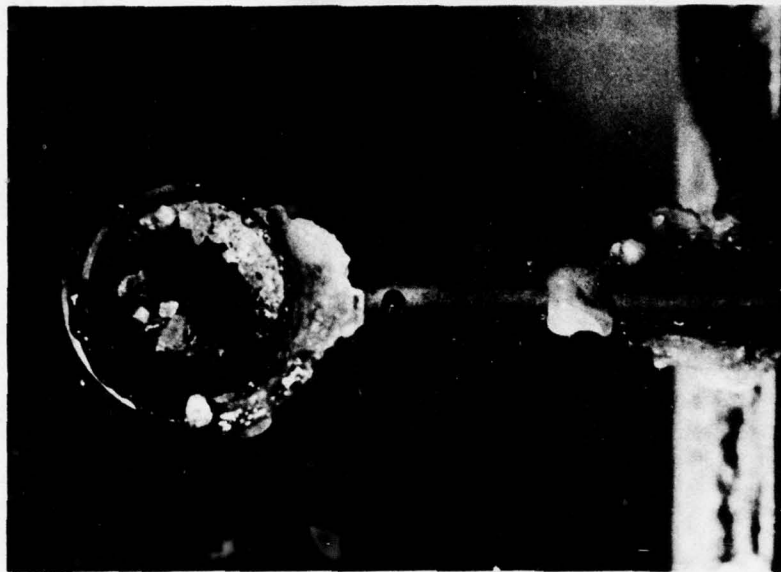
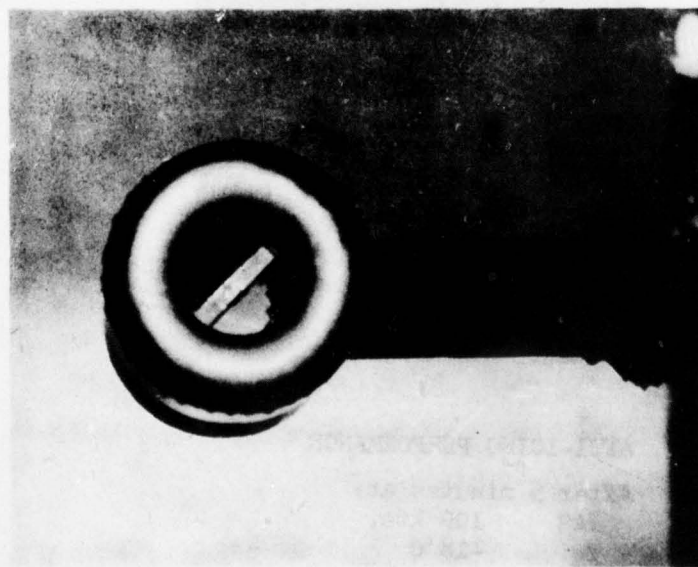
LTR-LT-77  
Fig. 6b

FIG. 6b ANTI-ICING PERFORMANCE

After 5 minutes at:  $\left\{ \begin{array}{l} \text{IAS} \\ T_S \\ \text{LWC} \end{array} \right. \begin{array}{l} 100 \text{ kts.} \\ -18^\circ\text{C} \\ 2.4 \text{ g/m}^3 \end{array}$

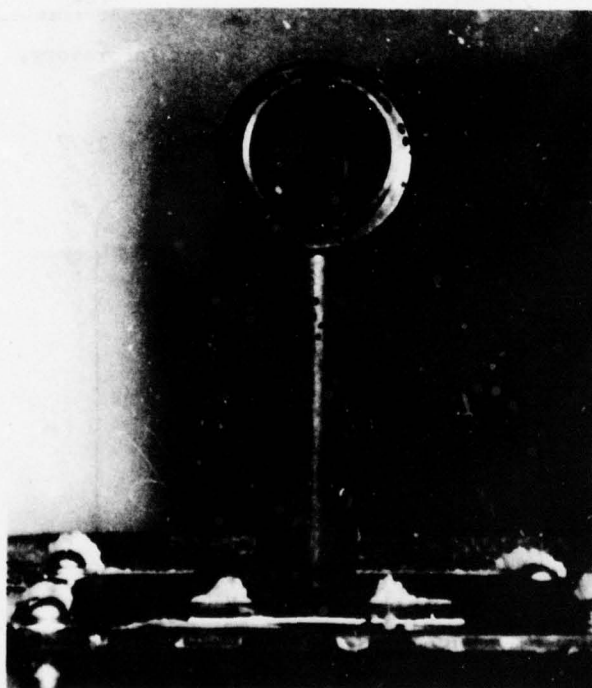
LTR-LT-77  
Fig. 7

Fig. 7 shows the detector after 10 minutes at 150 knots I.A.S.,  $-15^{\circ}\text{C}$  and  $0.56 \text{ g/m}^3$ . No problems were encountered under these conditions, and normal LWC indications were given throughout the run.

FIG. 7 ANTI-ICING PERFORMANCE
